Surface Appearance of Brushes

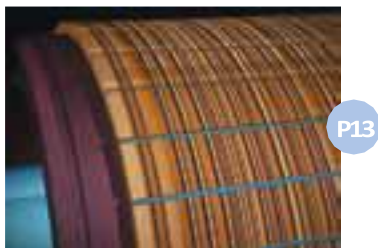
Patina Streaked with Collector Wear (P13)

A streaky film with no commutator wear, tracks can vary in width and color. Caused by atmospheric conditions (humidity, oil vapor or other gases) or insufficient load.

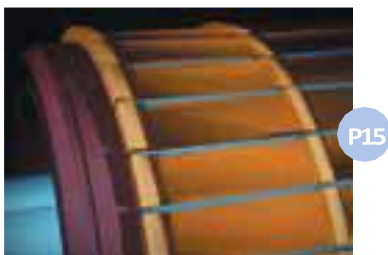
Grooving (P15)

It is the uniform circumferential wear, the width of the brush that is exhibited on the commutator. Excessive abrasive dust in the atmosphere or an abrasive brush can cause this condition. Extreme light spring pressure (below 1.5 psi) can also cause this condition. Proper brush applications and filtering the air on force ventilated motors can reduce the commutator wear.

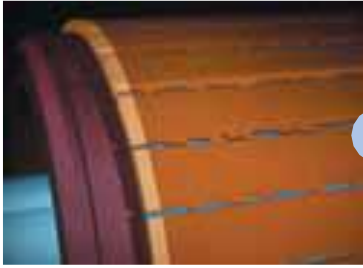
Copper Drag (P17)

Occurs when high energy transfers copper in a molten state. These particles become coated by contaminants from the surrounding environment or the brush treatment and do not oxidize properly to form the film on the commutator surface. These particles accumulate at the edge of the bar, eventually shorting across the insulating mica. This condition needs to be addressed immediately when discovered or serious damage may occur. Chamfering the commutator bar edges is necessary to stop the progression of this condition.

Copper pick-up from commutator surface can result from copper drag problems or heavy peak loads. It can cause further commutator wear.

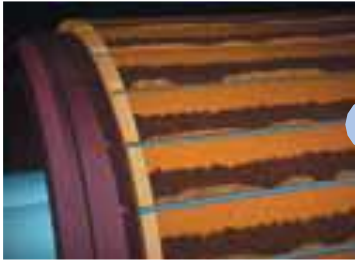
Bar Burning (B1)

Is the erosion of the trailing edge of the commutator bar. Failed machine components, maladjusted electrical symmetry of the machine or a poor commutating brush can result in bar burning. If not corrected, this condition can cause severe commutator damage or a flashover.

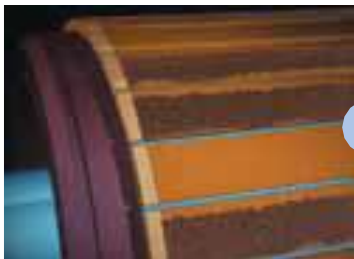
Slot Bar Burning (B3)

Results in commutator erosion of every second, third, or fourth bar depending on the winding design of the armature. Improper brush material, brush design or electrical adjustment of the machine can cause this condition. This condition severely damages the commutator and reduces brush life.

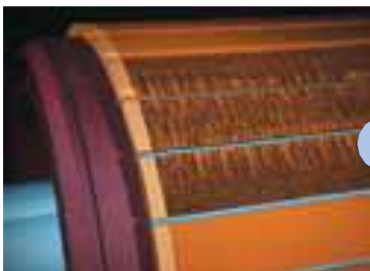
Pitch Bar Burning (B5)

Results in commutator bars being eroded in a pattern related to $1/2$ the number of brush arms, progressing into a pattern equal to the number of brush arms. This condition is caused by a cyclic mechanical or electrical disturbance such as an unbalanced armature, misaligned shafts, bent shaft, bad bearings, weak foundation, failed equalizers or a poor riser connection. If not corrected this condition will result in a flashover.
